<h3>Introduction</h3> <p>This double seam reference chart is intended for use by personnel responsible for setting and checking double seams. In addition, the chart will provide a useful guide to good double seaming practice, for engineers, production operators and quality assurance personnel.</p> <p>Its prime objective is to assist personnel whose decisions determine the quality of double seams.</p>	<h3>Can Terminology</h3>

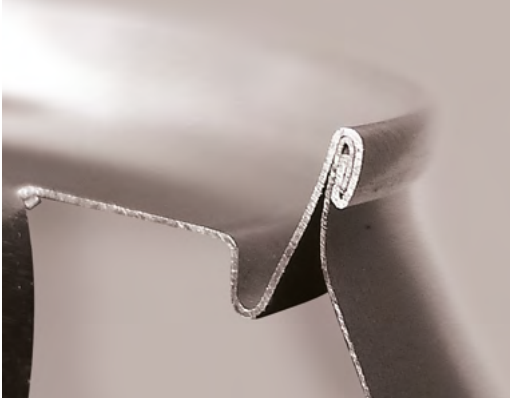
<h3>Double Seam Evaluation</h3> <ul style="list-style-type: none"> - Visual external examination - External measurements - Seam sections - Teardown examination

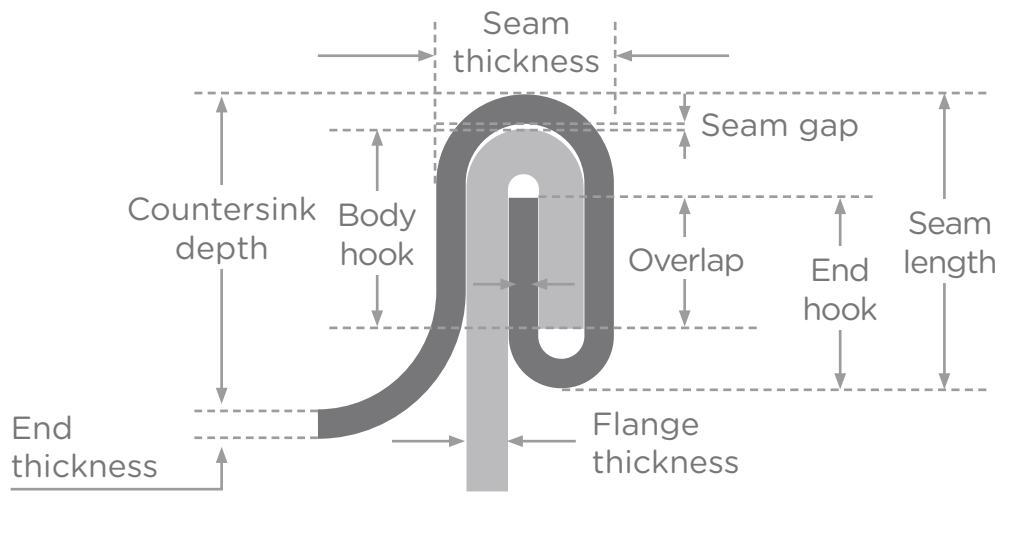
<h3>Evaluation Frequency</h3> <ul style="list-style-type: none"> - A visual check should be carried out every hour - A full 1st operation seam evaluation should be carried out once a week - A full 2nd operation seam evaluation should be carried out during every shift
<h3>Seam Evaluation</h3> <p>Critical Parameters:</p> <ul style="list-style-type: none"> - Tightness rating - Actual overlap - Body hook butting - Seam gap - Seam thickness <p>Other Parameters:</p> <ul style="list-style-type: none"> - Seam length - Countersink depth - Body hook - End hook

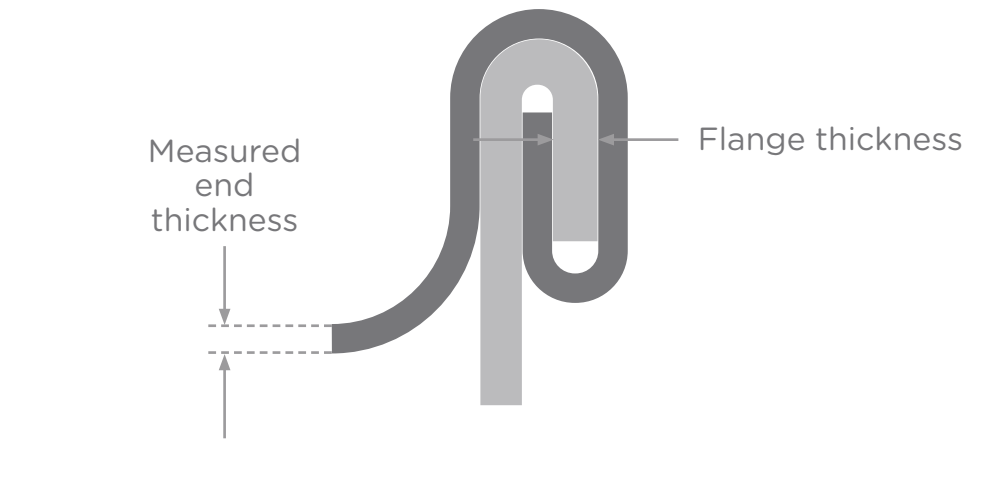
<h3>Typical Double Seam</h3>

<p>Nominal seam thickness = 3 x measured end thickness + 2 x can flange thickness + stealing compound</p>	<h3>External Seam Components</h3>

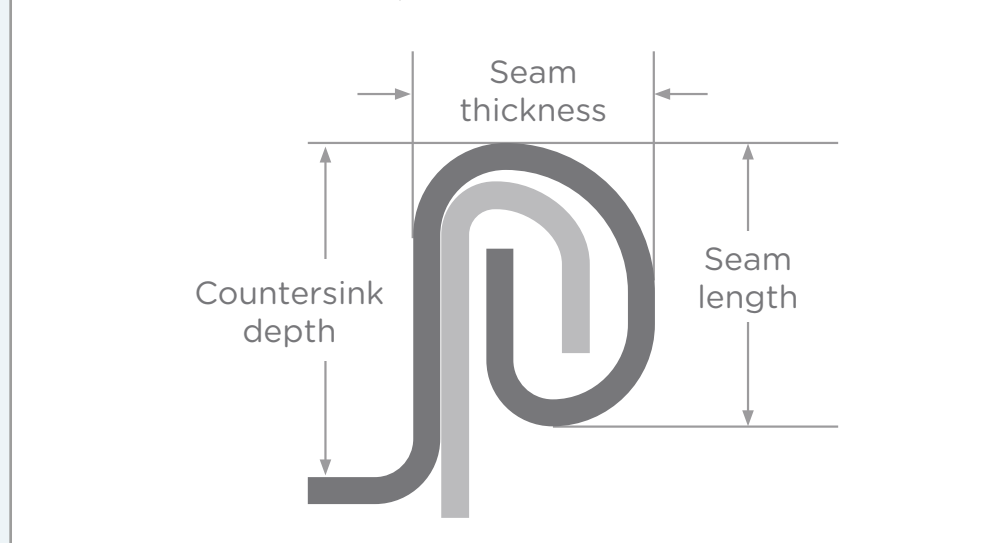
<h3>1st Operation Seam Evaluation</h3> <ul style="list-style-type: none"> - Seam thickness - Seam length - Countersink depth

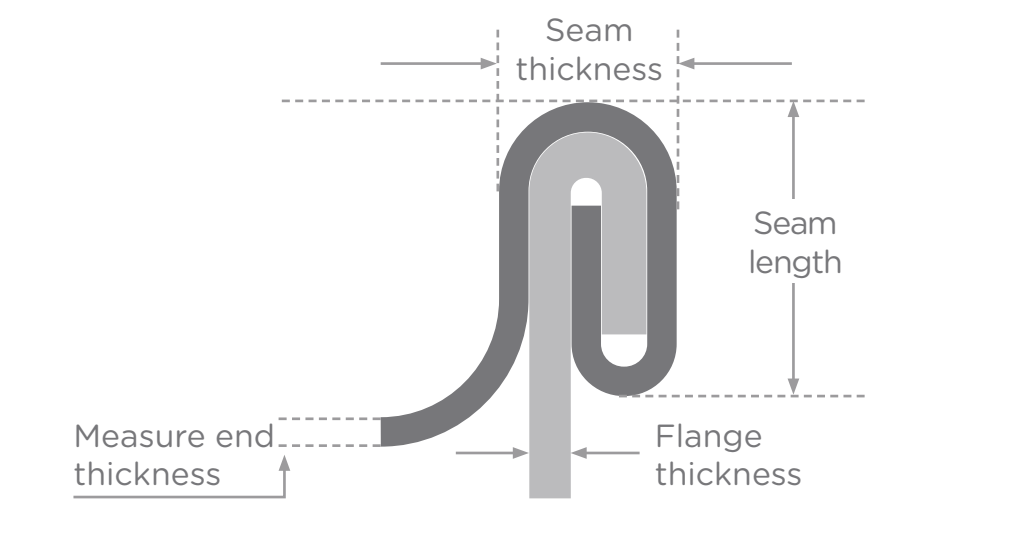
<h3>2nd Operation Seam Evaluation</h3> <ul style="list-style-type: none"> - No sharpness in upper portion of countersink - External dimensions within double seam specifications

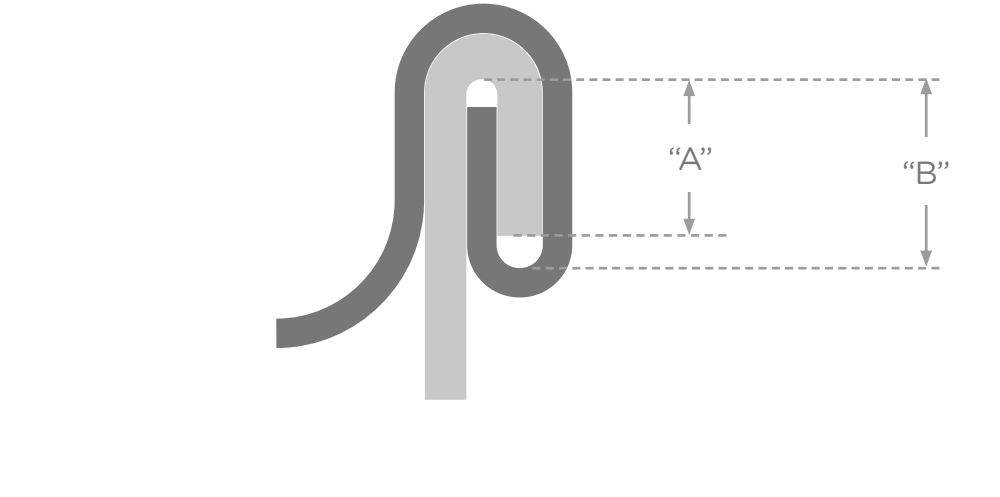
<h3>Body Hook Butting (BHB)</h3> <ul style="list-style-type: none"> - Calculated A/B x 100 = percentage

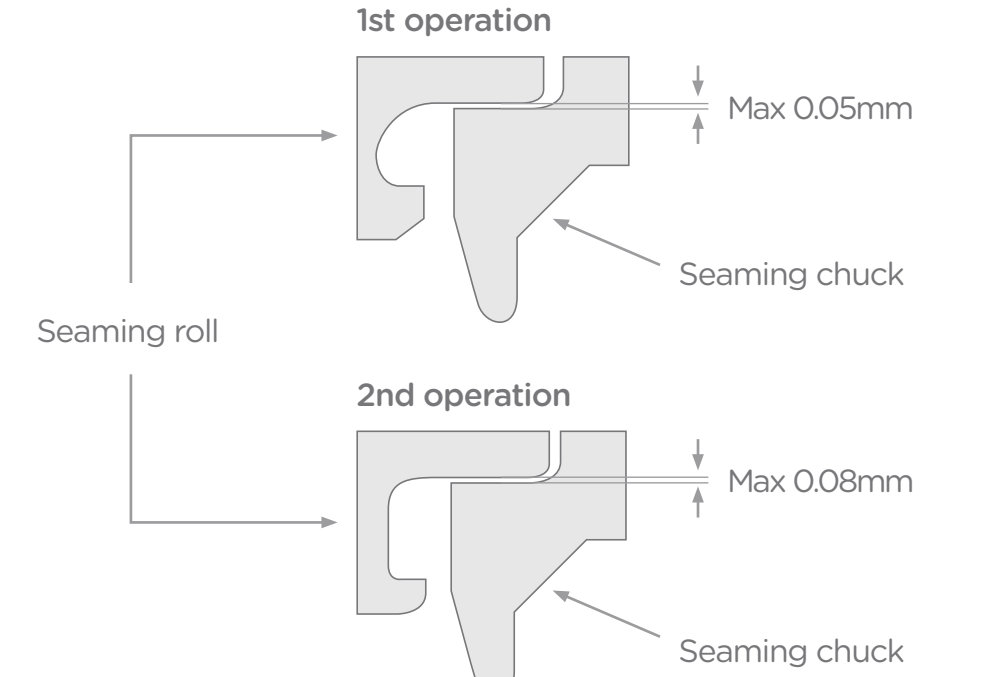
<h3>Seaming Process</h3> <ul style="list-style-type: none"> - Height adjustment - seaming chuck to roll clearance

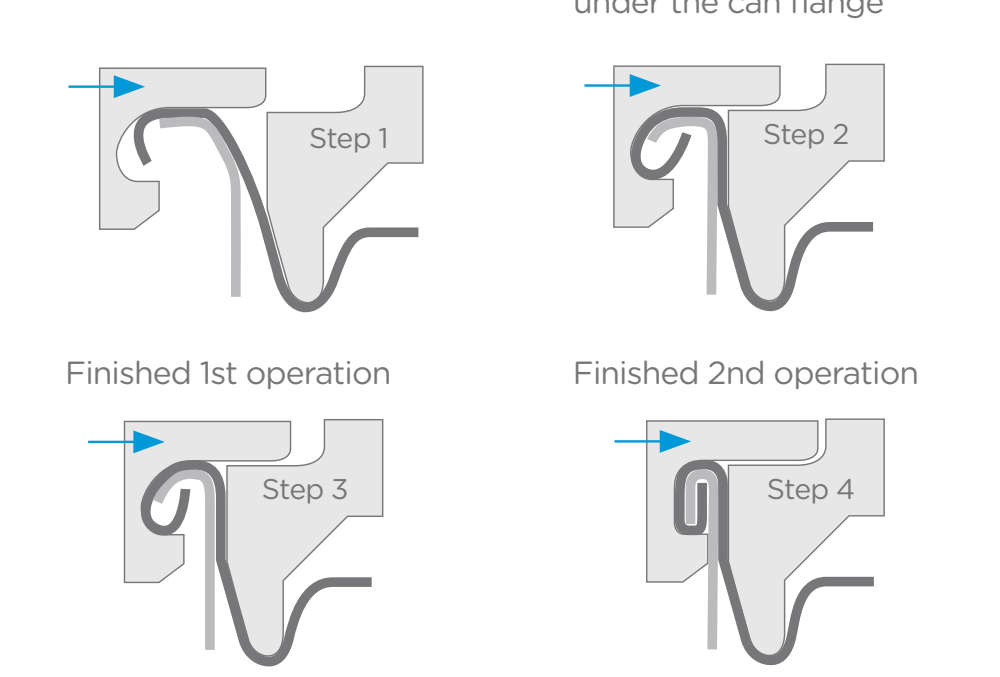
<h3>Seam Formation</h3> <p>Start of 1st operation seam formation</p> <p>Partially formed 1st operation seam - forming the end curl under the can flange</p>

<p>Finished 1st operation</p> <p>Finished 2nd operation</p>	<h3>Seaming Process</h3> <ul style="list-style-type: none"> - Pin gauge height - Distance between base-plate and chuck lip at the peak of 1st operation cam - Needs to be adjusted after can height change

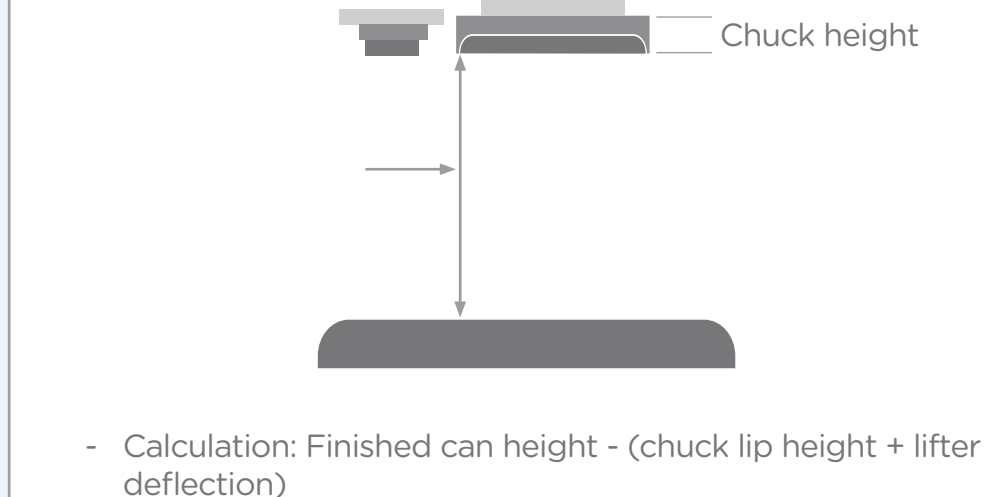
<p>Calculation: Finished can height - (chuck lip height + lifter deflection)</p>

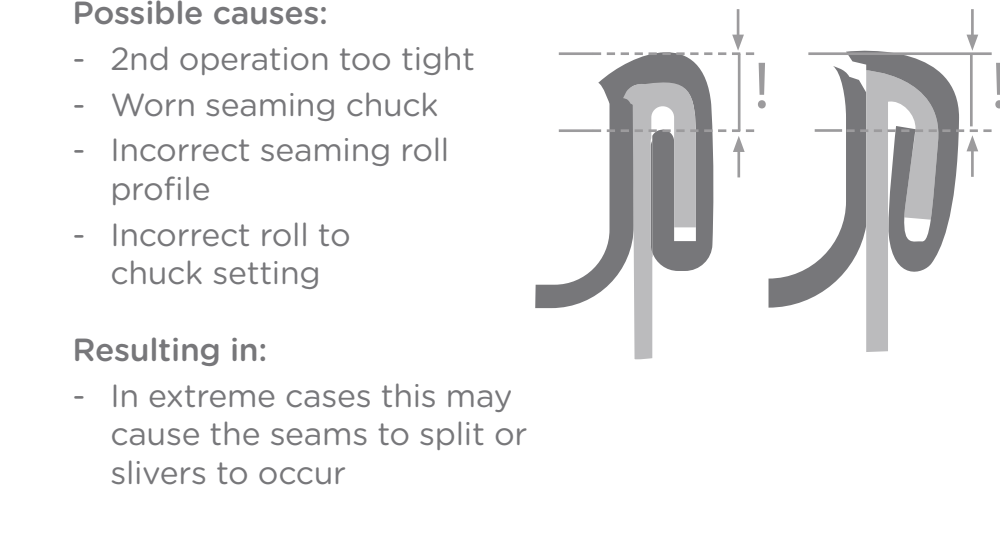
<h3>Sharp Seam/ Fractured Seam</h3> <p>This condition is identified where the seam has a sharp edge on the inner seam radius.</p> <p>Possible causes:</p> <ul style="list-style-type: none"> - 2nd operation too tight - Worn seaming chuck - Incorrect seaming roll profile - Incorrect roll to chuck setting <p>Resulting in:</p> <ul style="list-style-type: none"> - In extreme cases this may cause the seams to split or slivers to occur

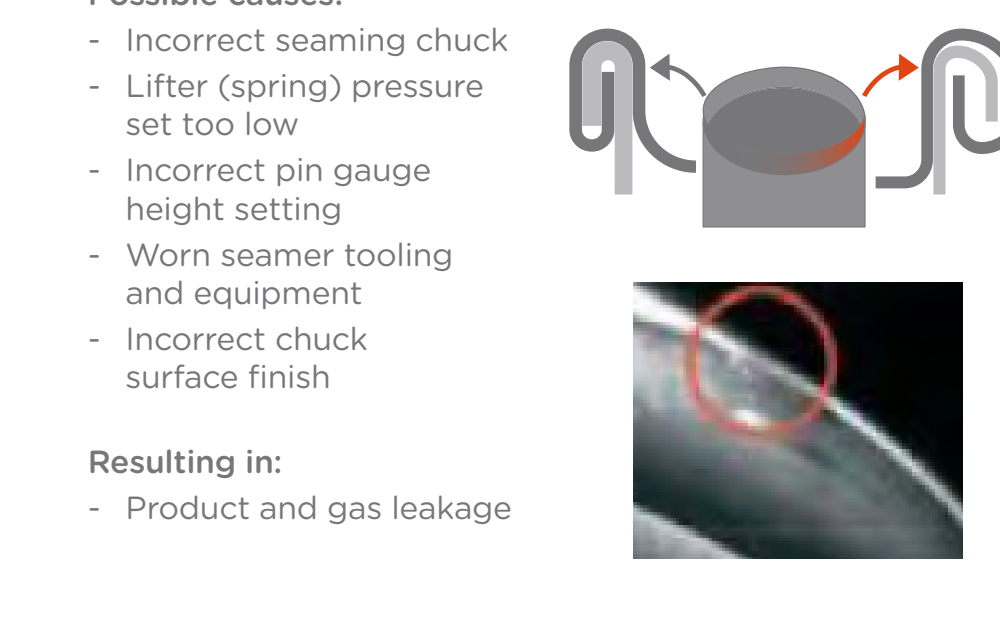
<h3>Skidder</h3> <p>An incomplete 2nd operation seam occurs when the can ceases to rotate during the seaming process.</p> <p>Possible causes:</p> <ul style="list-style-type: none"> - Incorrect seaming chuck - Lifter (spring) pressure set too low - Incorrect pin gauge height setting - Worn seamer tooling and equipment - Incorrect chuck surface finish <p>Resulting in:</p> <ul style="list-style-type: none"> - Product and gas leakage

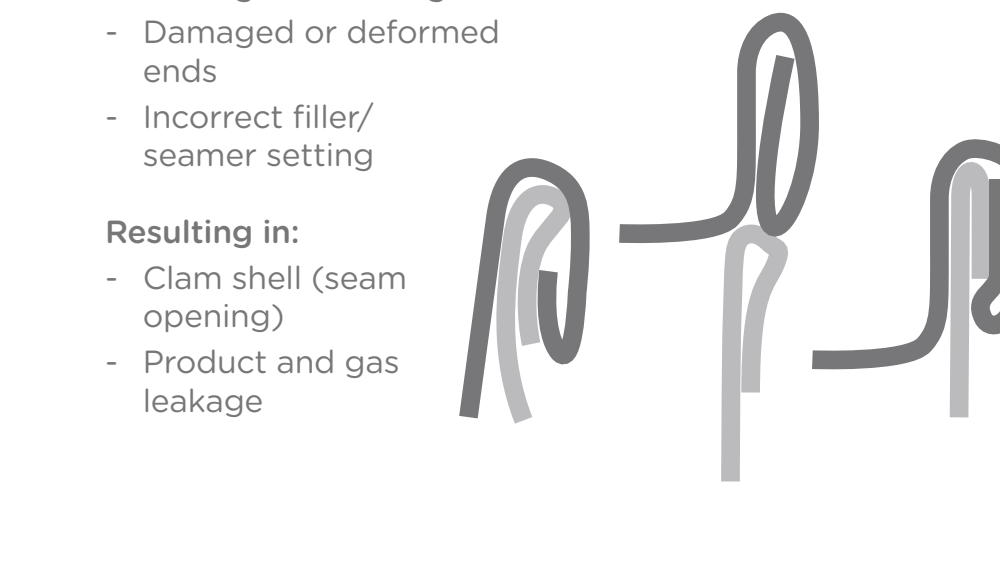
<h3>False Seam</h3> <p>Defect where a portion of the end and body hook are not interlocked</p> <p>Possible causes:</p> <ul style="list-style-type: none"> - Damaged can flange - Damaged or deformed ends - Incorrect filler/seamer setting <p>Resulting in:</p> <ul style="list-style-type: none"> - Clam shell (seam opening) - Product and gas leakage

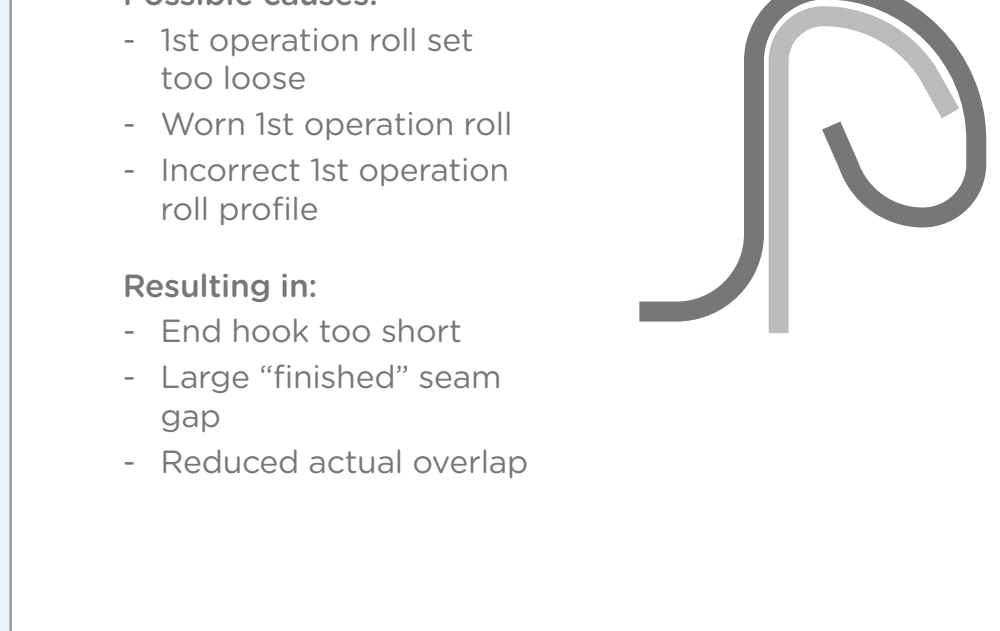
<h3>1st Operation too Loose</h3> <p>Possible causes:</p> <ul style="list-style-type: none"> - 1st operation roll set too loose - Worn 1st operation roll - Incorrect 1st operation roll profile <p>Resulting in:</p> <ul style="list-style-type: none"> - End hook too short - Large "finished" seam gap - Reduced actual overlap

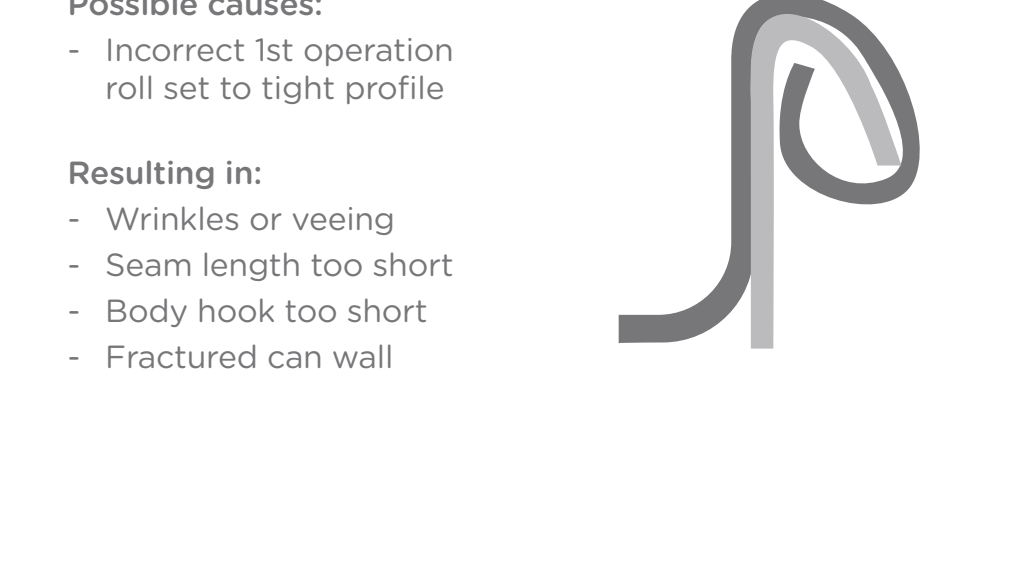
<h3>1st Operation too Tight</h3> <p>Possible causes:</p> <ul style="list-style-type: none"> - Incorrect 1st operation roll set to tight profile <p>Resulting in:</p> <ul style="list-style-type: none"> - Wrinkles or veeing - Seam length too short - Body hook too short - Fractured can wall

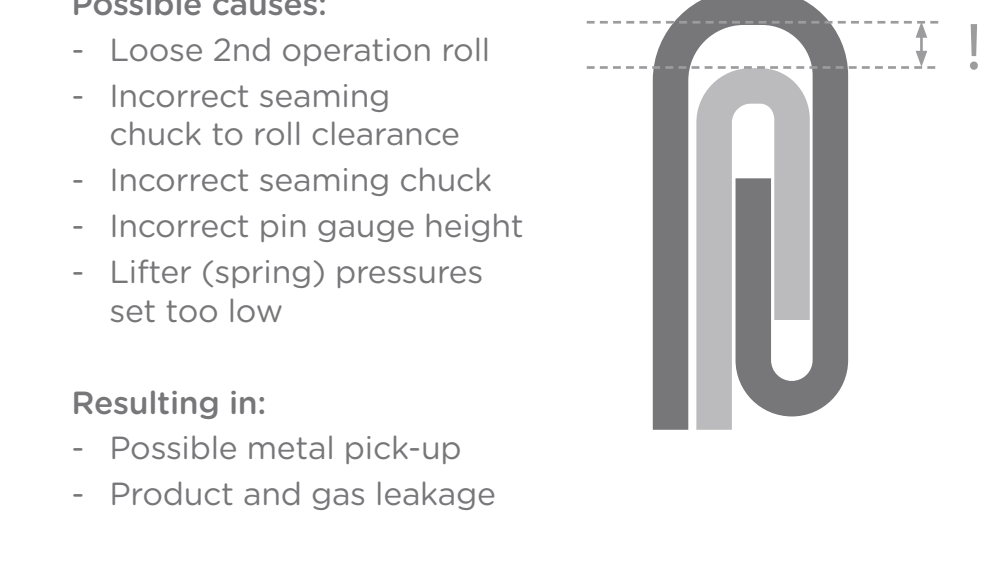
<h3>Excessive Seam Gap</h3> <p>Possible causes:</p> <ul style="list-style-type: none"> - Loose 2nd operation roll - Incorrect seaming chuck to roll clearance - Incorrect seaming chuck - Incorrect pin gauge height - Lifter (spring) pressures set too low <p>Resulting in:</p> <ul style="list-style-type: none"> - Possible metal pick-up - Product and gas leakage

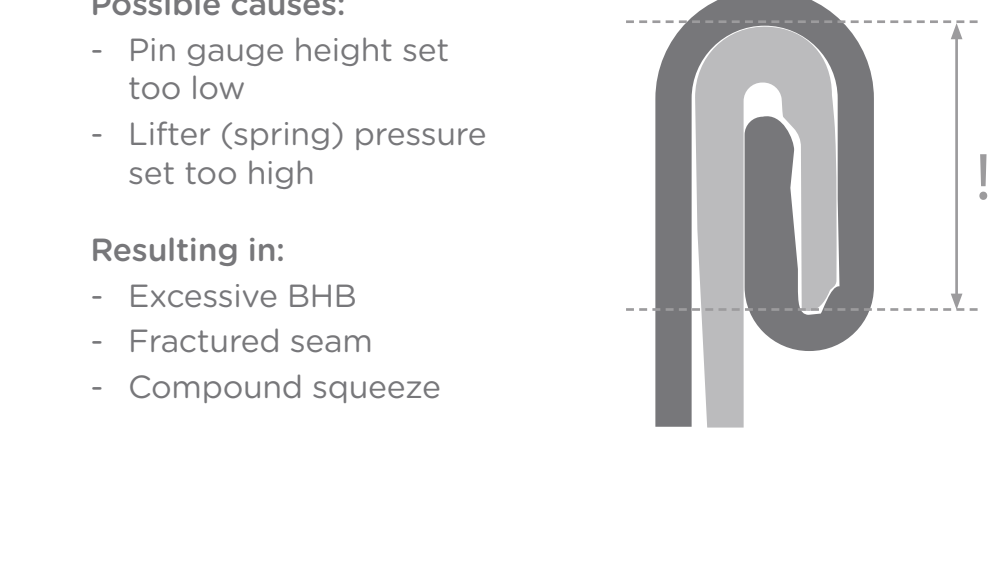
<h3>Body Hook too Long</h3> <p>Possible causes:</p> <ul style="list-style-type: none"> - Pin gauge height set too low - Lifter (spring) pressure set too high <p>Resulting in:</p> <ul style="list-style-type: none"> - Excessive BHB - Fractured seam - Compound squeeze

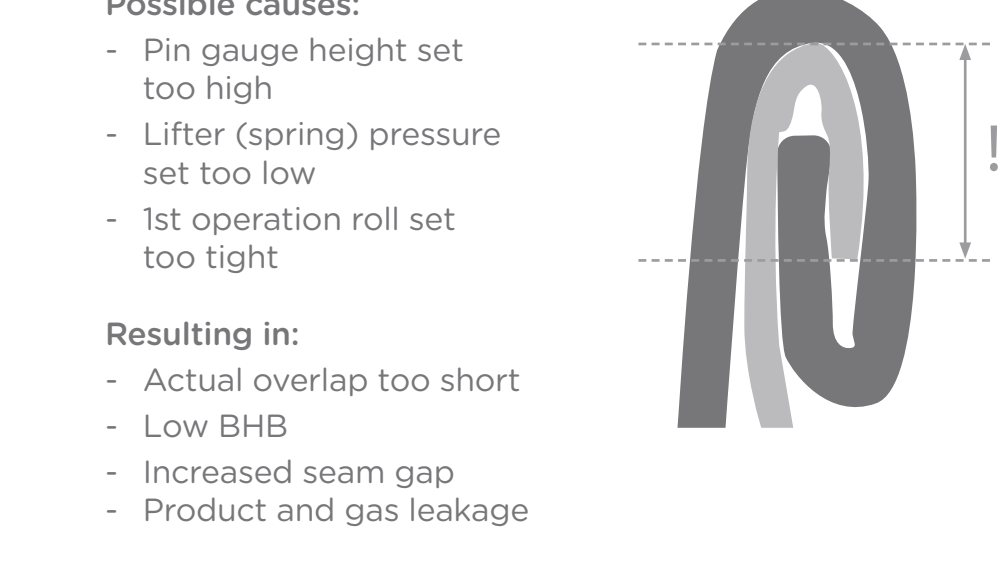
<h3>Body Hook too Short</h3> <p>Possible causes:</p> <ul style="list-style-type: none"> - Pin gauge height set too high - Lifter (spring) pressure set too low - 1st operation roll set too tight <p>Resulting in:</p> <ul style="list-style-type: none"> - Actual overlap too short - Low BHB - Increased seam gap - Product and gas leakage

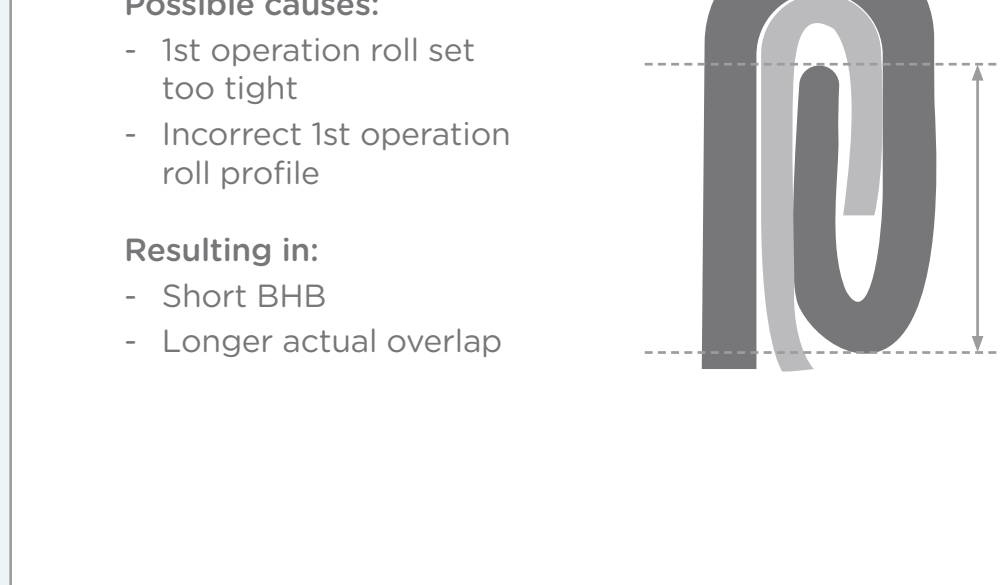
<h3>End Hook too Long</h3> <p>Possible causes:</p> <ul style="list-style-type: none"> - 1st operation roll set too tight - Incorrect 1st operation roll profile <p>Resulting in:</p> <ul style="list-style-type: none"> - Short BHB - Longer actual overlap

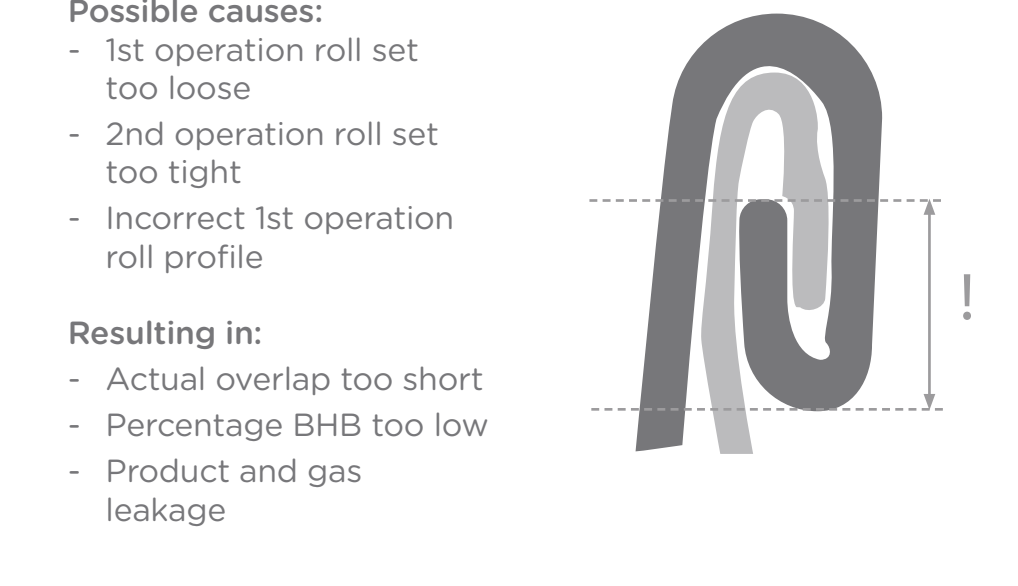
<h3>End Hook too Short</h3> <p>Possible causes:</p> <ul style="list-style-type: none"> - 1st operation roll set too loose - 2nd operation roll set too tight - Incorrect 1st operation roll profile <p>Resulting in:</p> <ul style="list-style-type: none"> - Actual overlap too short - Percentage BHB too low - Product and gas leakage

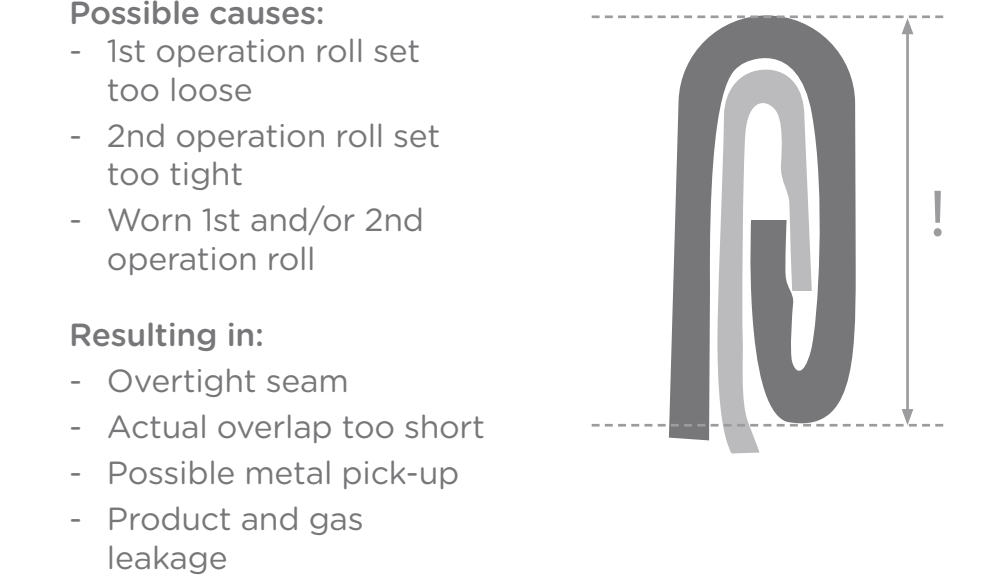
<h3>Excessive Seam Length</h3> <p>Possible causes:</p> <ul style="list-style-type: none"> - 1st operation roll set too loose - 2nd operation roll set too tight - Worn 1st and/or 2nd operation roll <p>Resulting in:</p> <ul style="list-style-type: none"> - Overtight seam - Actual overlap too short - Possible metal pick-up - Product and gas leakage

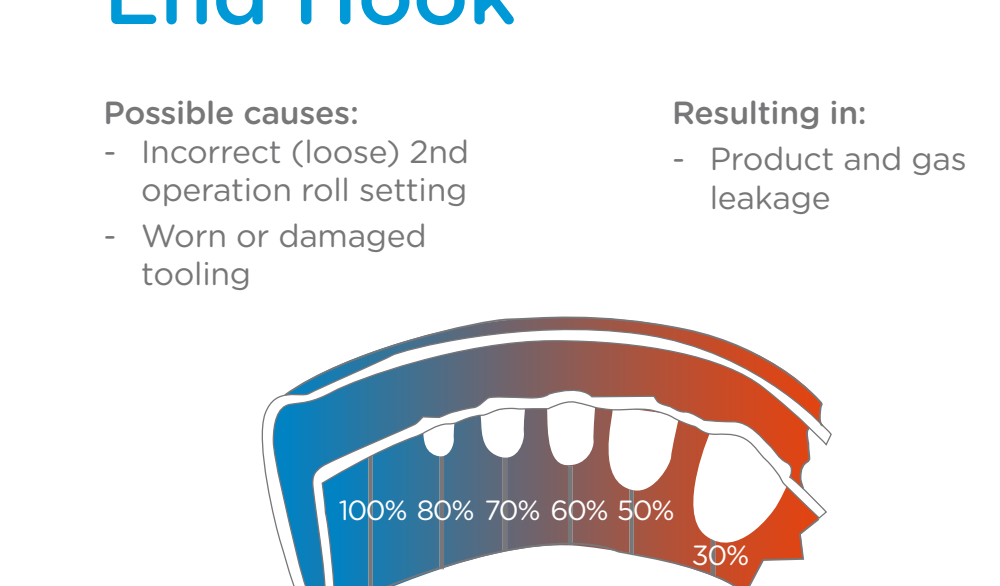
<h3>Wrinkles on the inside Face of the End Hook</h3> <p>Possible causes:</p> <ul style="list-style-type: none"> - Incorrect (loose) 2nd operation roll setting - Worn or damaged tooling <p>Resulting in:</p> <ul style="list-style-type: none"> - Product and gas leakage
